New Hampshire Volunteer Lake Assessment Program

2002 Interim Report for Rand Pond Goshen

NHDES Water Division Watershed Management Bureau 6 Hazen Drive Concord, NH 03301

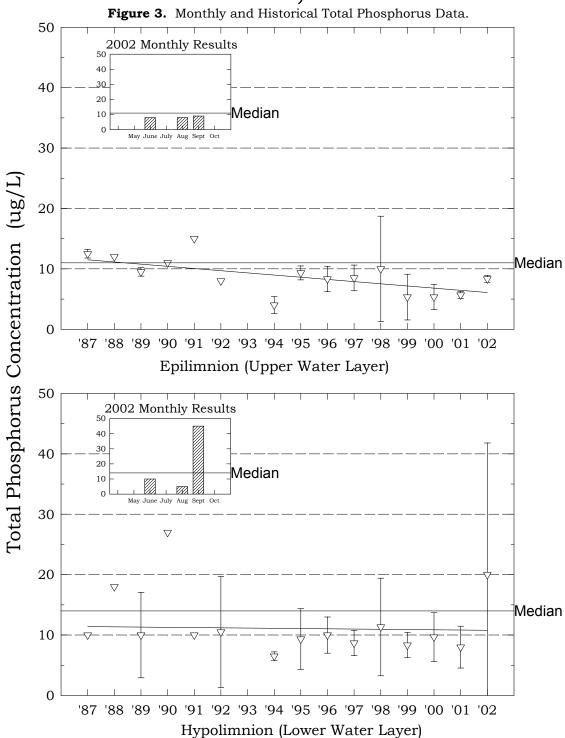
Figure 3 and Table 8: The graphs in Figure 3 (Appendix A) show the amounts of phosphorus in the epilimnion (the upper layer) and the hypolimnion (the lower layer); the inset graphs show current year data. Table 8 (Appendix B) lists the annual maximum, minimum, and median concentration for each deep spot layer and each tributary since the pond has joined the program.

The historical data for the epilimnion (upper layer) show that the 2002 total phosphorus mean is **less than** the state median. Overall, visual inspection of the historical data trend line for the epilimnion shows **a variable** total phosphorus trend, which means that the concentration has **fluctuated** in the epilimnion since monitoring began in 1987. It is worthy to note that the mean total phosphorus concentration in the epilimnion has **increased** (meaning **worsened**) since the year 1999.

The current year data for the hypolimnion (the bottom inset graph) show that the total phosphorus concentration was **very high** on the September sampling event. However, it is important to point out the that volunteer monitor noted that sediment was observed in the Kemmerer bottle after the phosphorus bottle was filled. This suggests

that the lake/pond bottom may have been disturbed by the anchor or by the Kemmerer Bottle while sampling. When the lake/pond bottom is disturbed, sediment, which typically contains attached phosphorus, is released into the water column. When collecting the hypolimnion sample, please check to make sure that there is no sediment in the Kemmerer Bottle before filling the sample bottles.

The historical data for the hypolimnion (lower layer) show that the 2002 total phosphorus mean is **greater than** the state median. Overall, visual inspection of the historical data trend line for the hypolimnion also shows **a variable** total phosphorus trend, which means that the concentration has **fluctuated** in the hypolimnion since monitoring began.

One of the most important approaches to reducing phosphorus loading to a waterbody is to continually educate watershed residents about its sources and how excessive amounts can adversely impact the ecology and value of lakes and ponds. Phosphorus sources within a lake or pond's watershed typically include septic systems, animal waste, lawn fertilizer, road and construction erosion, and natural wetlands. If you would like to educate watershed residents about how they can help to reduce phosphorus loading into the lake, please contact the VLAP Coordinator.
